Quality Assurance in Capital Projects

This article is an introduction to Quality Assurance (QA) and presents a few case studies that can be used to describe XPS' QA approach in action during testing and design, fabrication and construction.

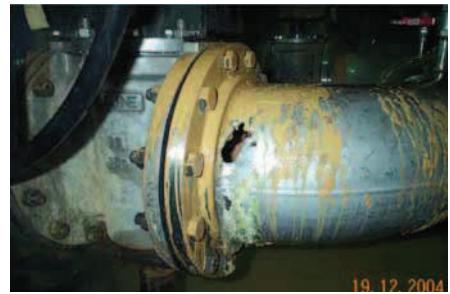
During the expansion of a zinc leaching operation, new equipment was added to an existing plant to recover precious metals from leaching residues. The most critical part of the expansion was the fabrication and construction of three new leach tanks. The environment consisted of leaching the residue with a solution containing 100g/l H₂SO₄ at 95°C, redox potential = 350mV and maximum chloride content of 50ppm. Another section of the plant had similar leaching tanks operating at approximately 80g/l H₂SO₄ at 90°C. The old tanks were lined with acid resistant masonry and respective membrane. However, the owner requested that the new tanks had to be built using metallic materials only. Corrosion tests of candidate materials were performed with solution from the old tanks with their parameters adjusted to the new conditions. The alloys tested were 904L, 254SMO, Zeron 100, 20Cb3, and Inconel 625. The selection of some of the candidate materials was based on experience in similar environments. Following the corrosion tests, alloy 904L was selected. The QA program for the tanks proceeded with detailed design review, inspections during fabrication and construction. However, the QA program was restricted to the tanks only. Approximately three weeks into commissioning, leaks developed along pipelines, valves and flowmeters, all due to corrosion. The photo (right) illustrates a corroded

Corroded pipe spool from high acid leach tank

pipe spool at the tank discharge line. The condition of the tanks became the main concern since failure of the tanks would lead to a major shutdown and re-assessment of the project. Corroded pipe spools, valves and flowmeters were sent to the Materials Technology laboratory of XPS for analysis. The analysis indicated that all corroded components were made of stainless steel type 316 rather than the 904L alloy used for the tank. The tanks were emptied and inspected and no corrosion was found. In conclusion, an adequate QA program was implemented during the tank fabrication but little attention was paid to ancillary equipment. All corroded equipment was replaced with 904L alloy.

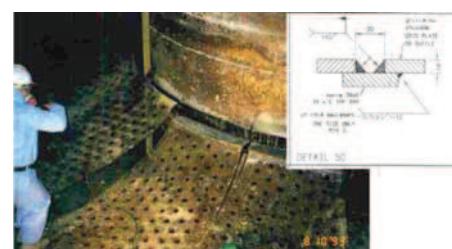
Catalyst bed failure

A sulfuric SO₂ gas converter from a sulfuric acid plant failed only a few months after it went into service causing a prolonged smelter shutdown. The failure consisted of the collapse of one catalyst bed, consequently causing the converter to lose its functionality. The equipment had to be opened and the catalyst removed to facilitate equipment inspection. Inspection revealed that one of the longitudinal welds connecting two bed segments had failed causing the bed to collapse. Close examination showed that the failed weld was intermittent instead of continuous. However,

the construction drawings clearly specified continuous welds and provided clear weld design details. The photo (right) depicts the collapsed bed and the weld design detail from the fabrication drawing. The investigation clearly showed that in this case the material selection, design and specifications were all properly done. However, the project lacked proper surveillance during construction. The lesson learned here is that the QA cycle has to be complete, from the initial project development to execution. The exclusion of one QA step can lead to costly consequences.

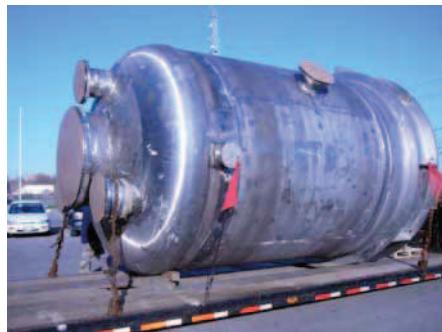
Autoclave shell

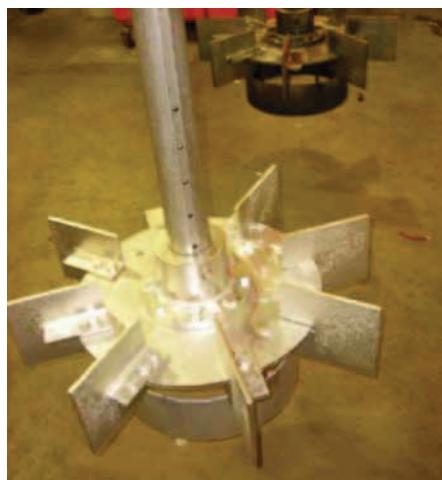
Mixer and shaft

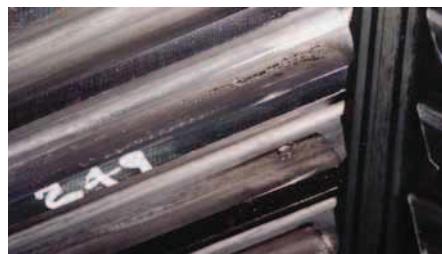
After the failure of a hoist bull gear from an underground mine, a new fabricated gear was installed and started to develop progressive pits on its teeth face immediately after it went into service. The photo (right) depicts the details of progressive pitting on one tooth of the newly installed gear. Only the original drawing and performance parameters had been used as procurement documents. Therefore, no quality assurance dossier was delivered with the gear. The gear hub and spokes were made of welded carbon steel while the rim was made of quenched and tempered low alloy steel and welded onto the spokes. The gear supplier initially suggested that the pitting was due to normal run in. However, the owner and the supplier decided to perform weekly inspections to assess the progression of the pitting damage. After three months in operation it was concluded that the pits were in fact progressive pitting, which could lead the gear to catastrophic failure. Nothing had been changed in the mine regarding the hoist loading and speed as well as the lubrication system. The gear had also been replaced in kind with exactly the same dimensions as the original one. Close examination revealed that the pitting damage followed a pattern, being very pronounced every sixth tooth. Therefore, there was evidence of potential dimensional errors on the gear which had most likely originated during the gear fabrication. A

detailed dimensional inspection was then performed on site and the results indicated that some teeth were thicker than others. Furthermore, the thicker teeth followed a pattern of every sixth tooth, consistent with the pitting pattern. The supplier then proceeded to inspect its own gear cutting equipment and the defective teeth were traced back to off-spec cutting tools. Another gear had to be fabricated to replace the defective one. The lesson learned here is that a proper QA procedure, which included dimensional checks of the fabricated gear, would have prevented the failure. Since then, a detailed specification has been used for the procurement of bull gears, which amongst other things has requirements for inspection and testing plans, including detailed dimensional inspections at the fabrication shop.

Progressive pitting damage on gear tooth face
